What is this? BSI failure, due to water ingress or firmware corruption (because of incorrect shutdown/booting), is reasonably common. The BSI is part of the immobiliser system, so the normal approach is to swap the BSI/ECU/transponder with a set from a a donor car. The BSI and clocks both store the mileage - if you fit a replacement BSI with higher mileage then the display will show that higher value, which is undesirable. With the cars aging, BSI/ECU/key/clocks kits with low mileage are becoming rare (and thus expensive). This technique removes all of these problems, allowing a direct BSI swap and preserving the immobiliser and mileage. How is it done? The BSI contains an EEPROM (electronically erasable programmable read only memory) which is nonvolatile (preserved

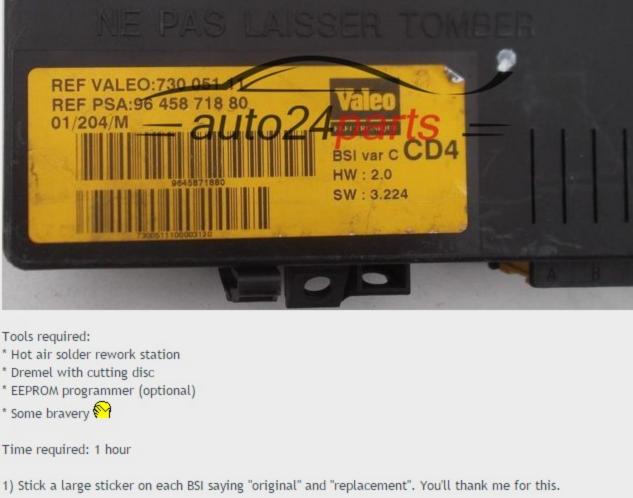
the bright yellow sticker. Erring on the side of caution, I got one with the same HW and SW version numbers too. I believe the HW number is important (usually either 2.0 or 3.0, and there are many of both flavours floating around). I believe SW version can be slightly different, but I haven't tested this. I believe this technique is valid for CD3 and CD4 BSI units by Valeo (full mux cars). I am unsure about Valeo CD1 units. The Siemens BSI units (semi mux cars) are likely to be similar but I don't have one to test on right now (volunteers?!).

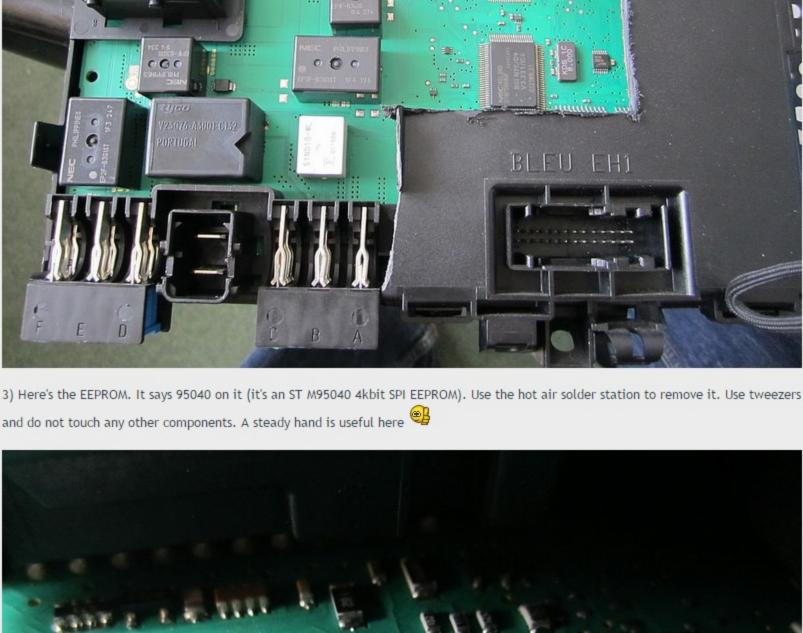
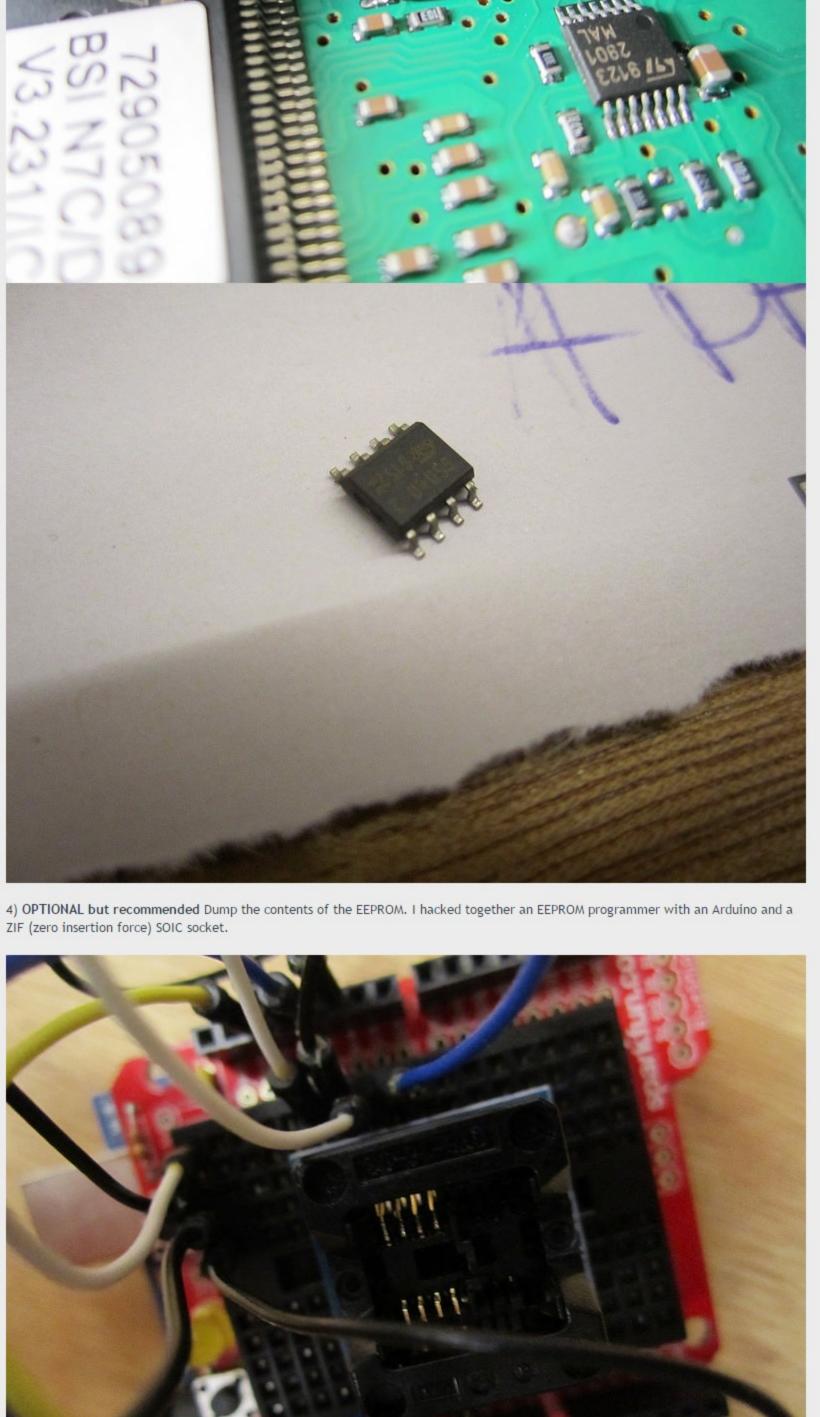
- but isn't helpful. The EEPROM chip we need to access is under the front cover, which can't be removed since it's part of the connectors (thanks Valeo). I knew my old BSI was dead so I gently snapped the casing away on the left hand side of the picture. I then dremelled the
- square slot out of the right hand side. There is a fair amount of clearance under the dremelled square, but mind the two black relays! DO NOT touch any of the circuit boards.

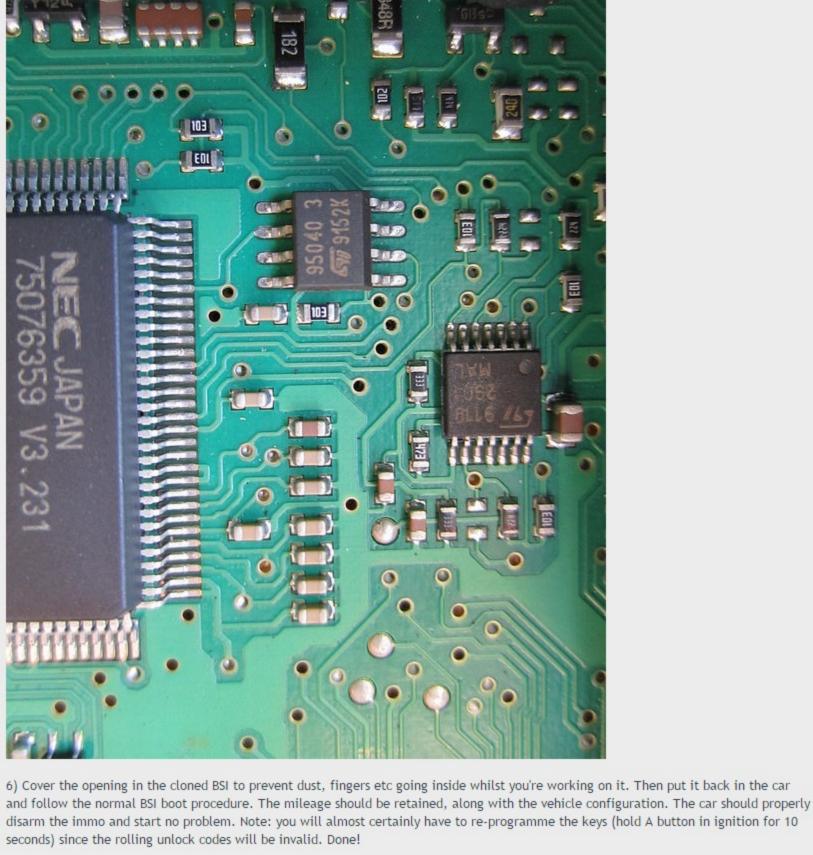
5) Carry out the same case surgery on the replacement BSI. Remove the EEPROM and set aside (no use to us right now). Then use the hot
air station to solder the old EEPROM into the replacement BSI. Don't get them mixed up! Here's a pic showing the orientation of the
chip.
```
