Quick and easy cleaning job requiring little more than basic tools and a steady hand. Should take less than half an hour. The sensor and connected fan unit that samples cabin air is located in the overhead lighting unit. Over the years this collects dust and dirt from the air, clogging up the delicate little fan and coating the sensor.

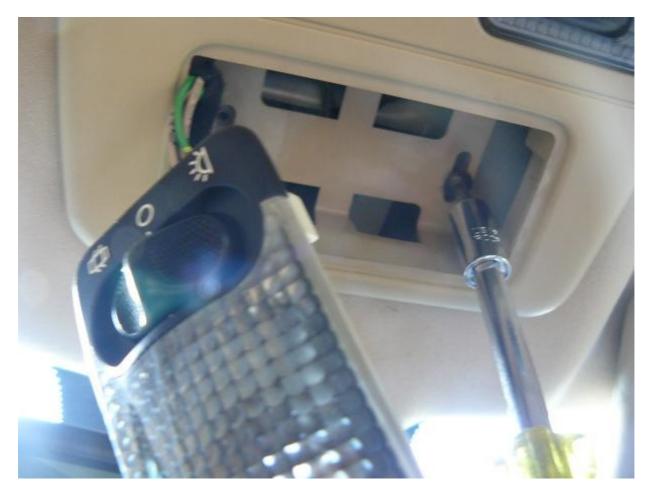
1. Use the flatblade screwdriver to pop out the overhead interior light from its unit. Once free, remove the two screws that hold the console in place - small Torx in my example (can't remember the size) but may differ in your car

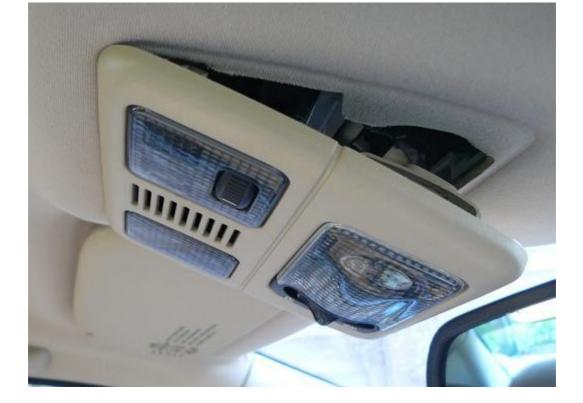
2. I then pushed the light back into the console before dropping it all down, though you don't haqve to do that. Just use the flatblade screwdriver once again to pop out the front-side of the unit. The rear edge has lugs which locate against the headlining, but once the front is eased out, the whole unit will drop down.

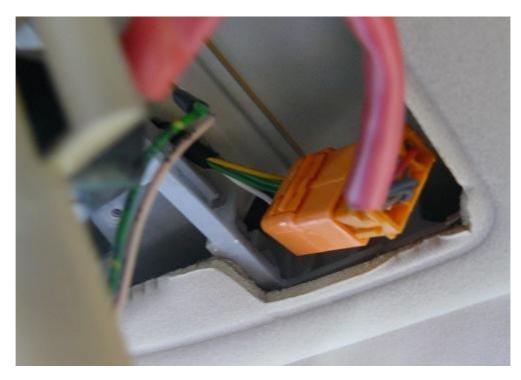
3. Next step is to remove the black fan unit from the console. First, detach its orange electrical connector. This was tucked up on the right hand side in the roof void.

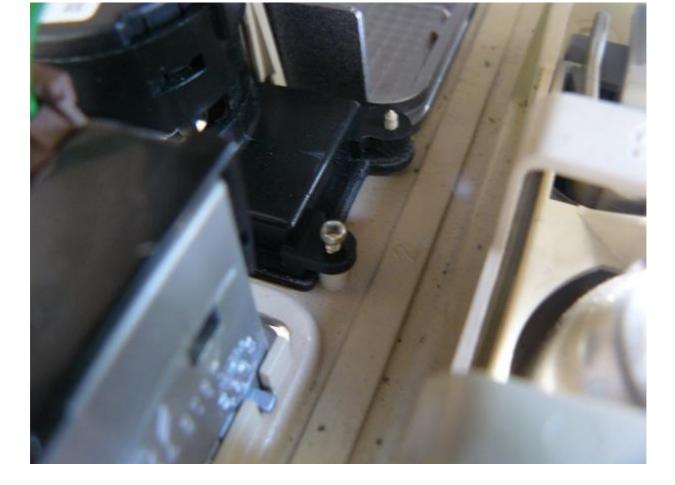
4. Then remove the tiny screws with the jewellers-type crosshead screwdriver. There are two screws on opposite corners of the module - opposing corners are simply located on plastic pins. This pic shows one screw and one pin. As these are tiny screws and you are working above your head, be VERY careful not to drop them as they come away ... take it easy

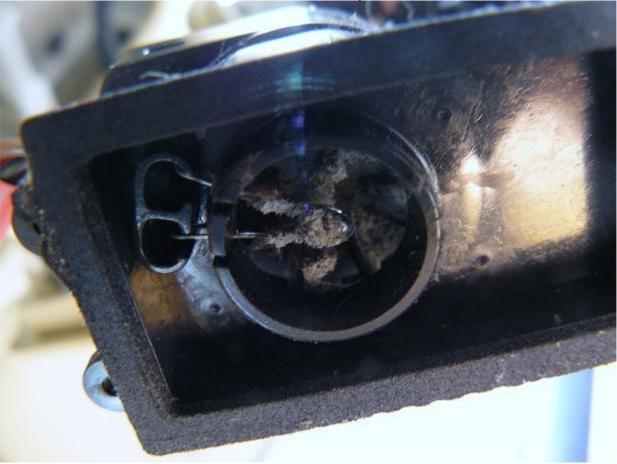
5. You should now have the back fan unit free to work on. I took mine in the house and found a small fine art brush to clean it. Here is the dirty before shot. You can see the air temperature sensor located out on two pins in the centre of the direction of airflow ... the fan is up behind it.

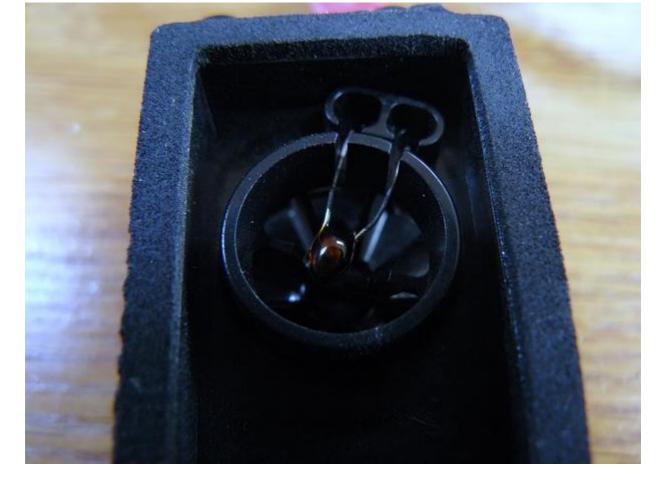
6. A few minutes careful brushing later and this is the result
