How To - Replace your Coupe's Door and All of its Accessories

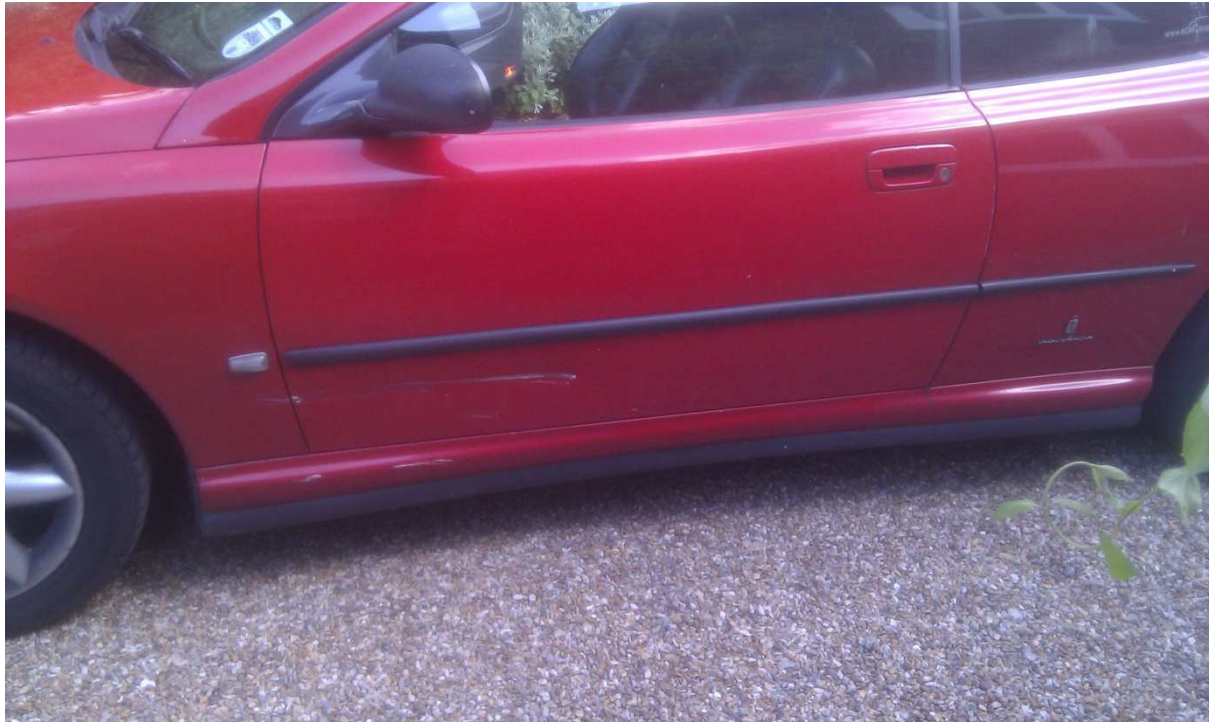
The next picture show's my car with a nice scar in the door.

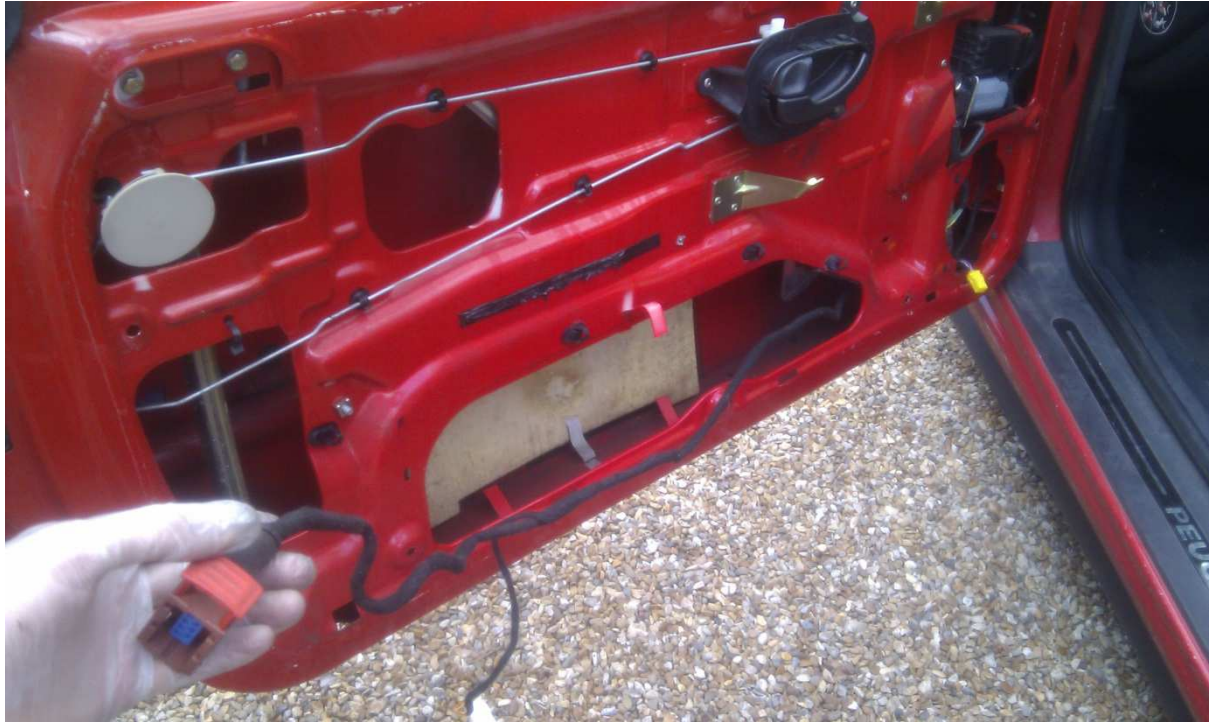
This image shows the fact that I have removed the lock loom from the locking mechanism. The window will rise to its fully closed position. This happens because the locking mechanism tells the ECU if the door has been closed and if the window needs to be raised to fully closed or not.

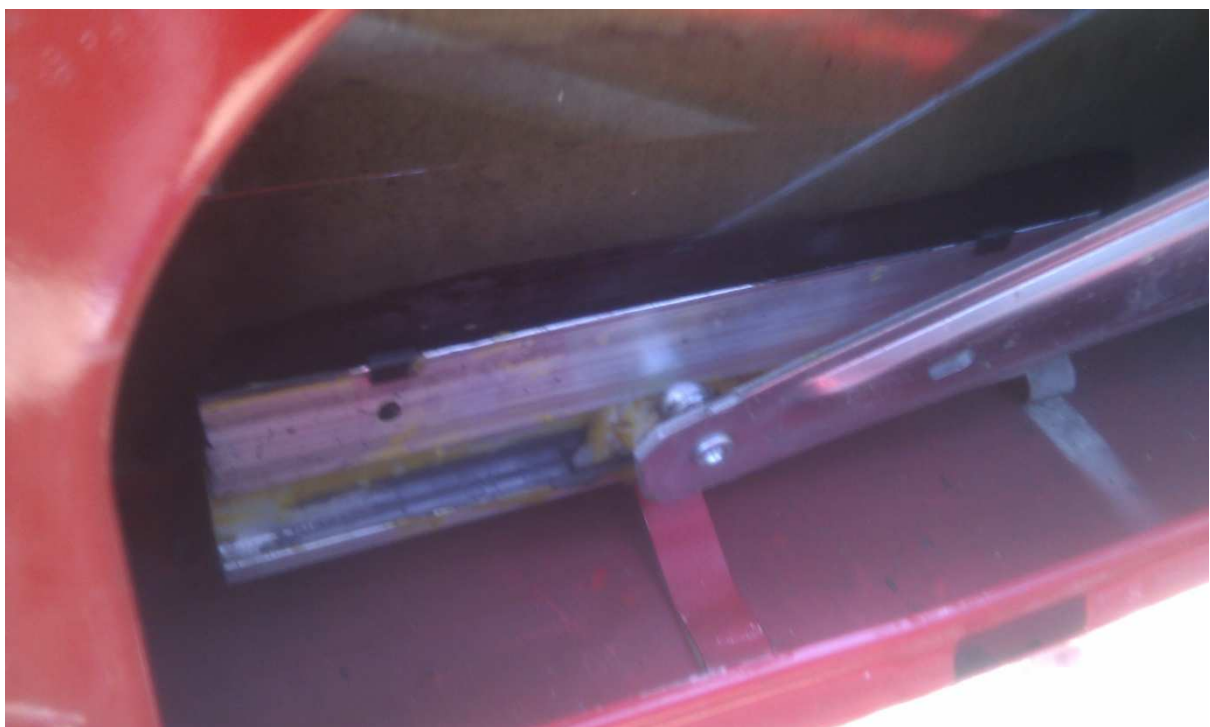
Here is the result of popping the ball joint out. Be careful, it requires considerable force and can lead to snapped plastic, see next image.

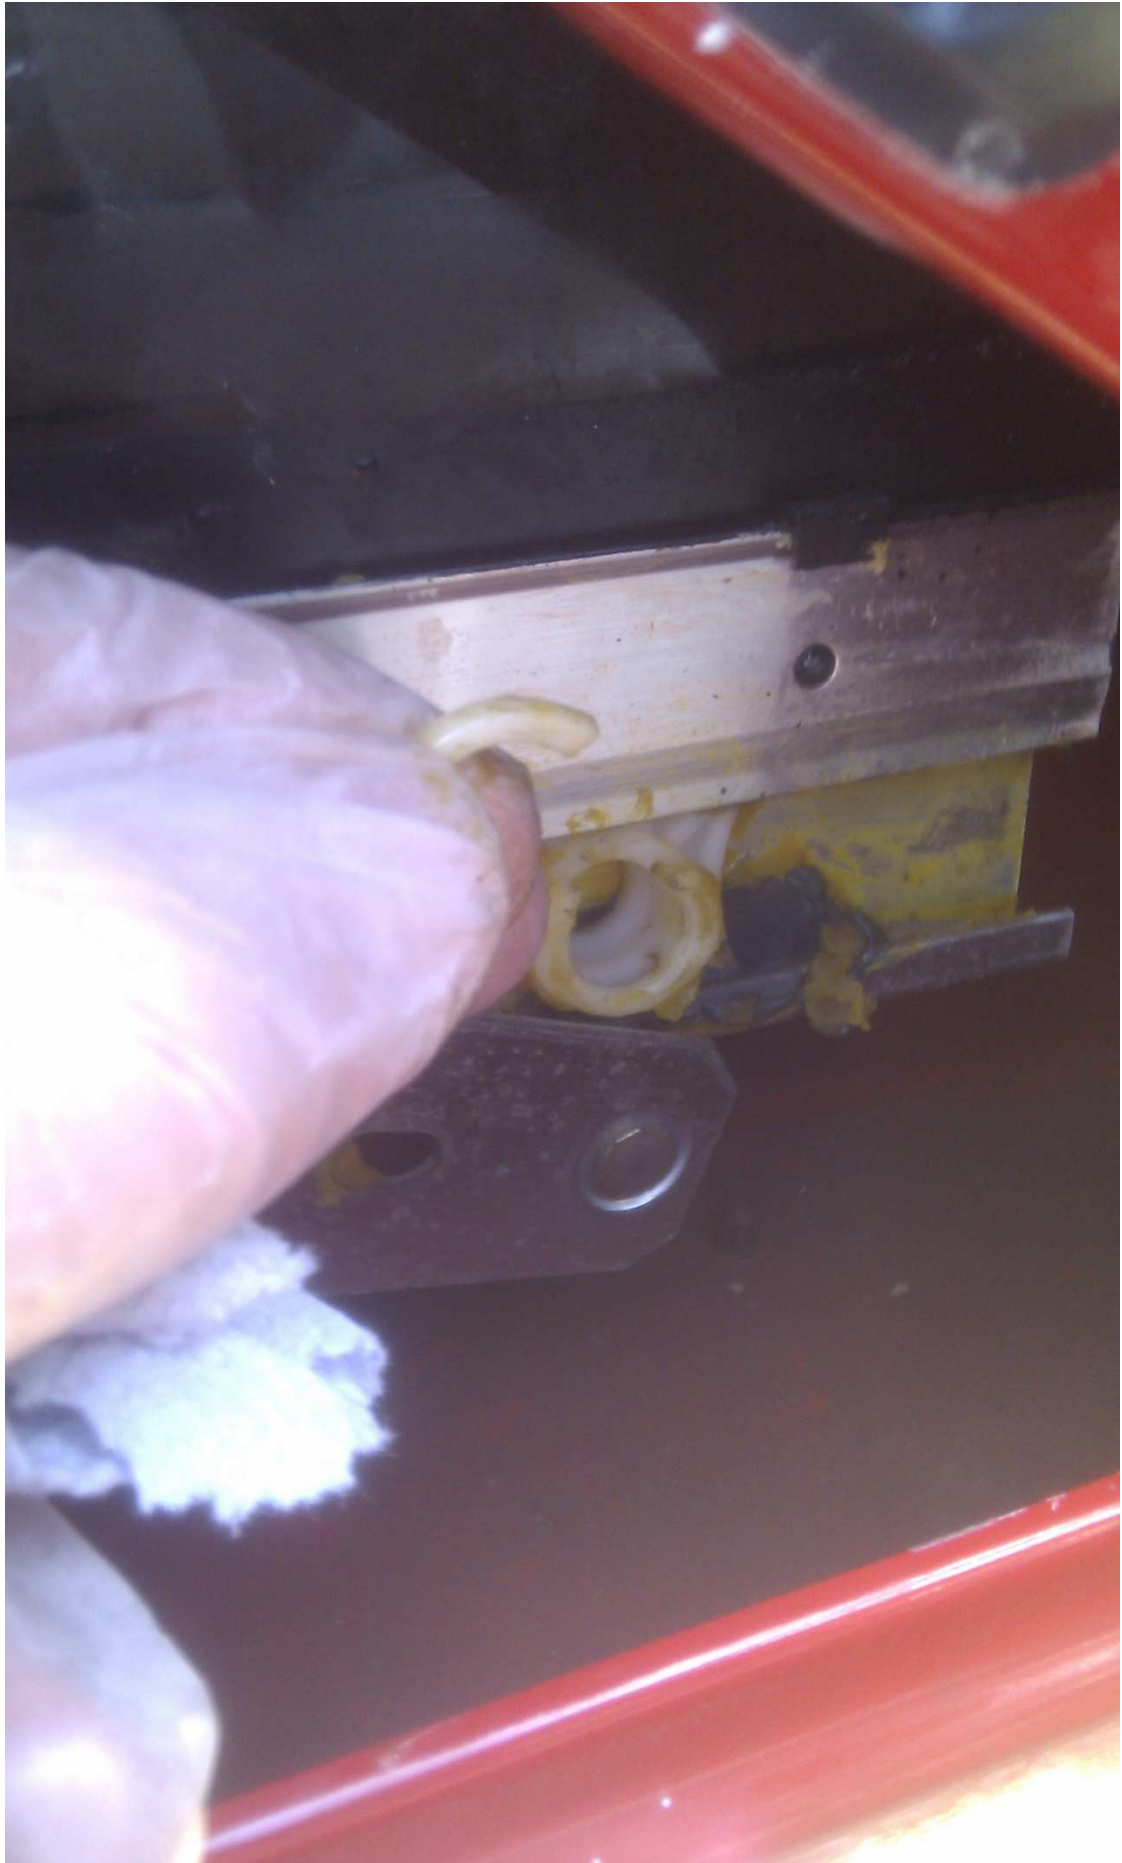
Here you can see the runner is no longer a perfect circle, I should have replaced it with a spare but it is still serviceable in this state.

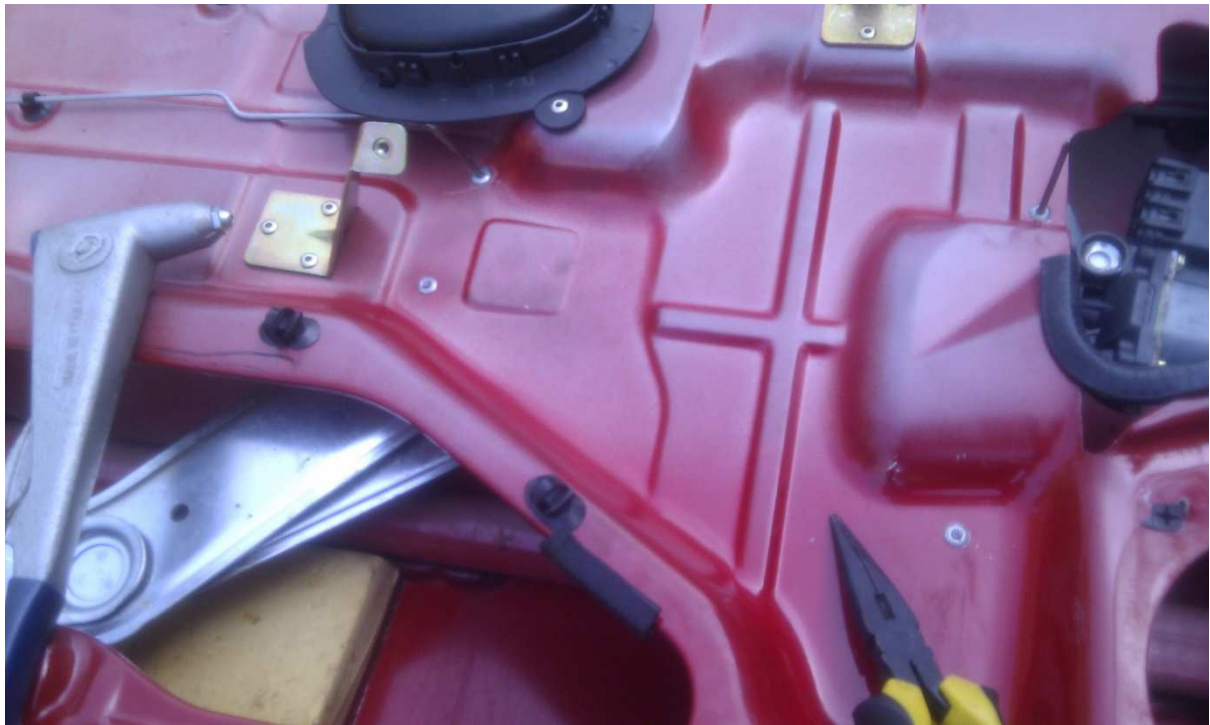
Here you can see at least one of the newly applied rivets still has its nail sticking out. Just felt it would be a useful shot for anyone who had never used a rivet gun before.

This is how NOT to do it. My dad explained to me that what should have happened was, the tensile strain of tightening the rivets should have broken away the remainder of the nail. As luck would have it I got them near as damn-it close, but just hadn't broken the ends off the nail, so I cut them off with bolt cutters.

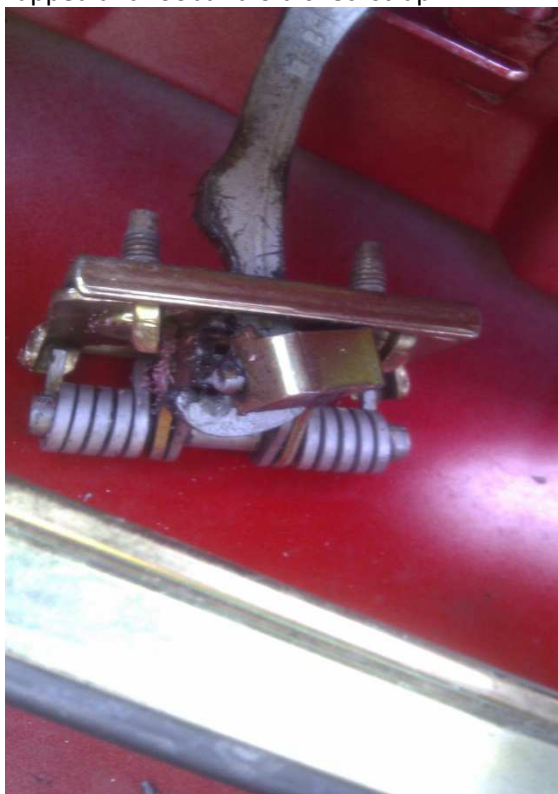
This image is to show the snapped and foobar'd old checkstrap.
