Symptoms leading me to replace this resistor was simple, I had the aircon on in the car with the blowers on speed 3 & all of a sudden they just stopped. They wouldn't work at any speed, nor was the compressor engaging.

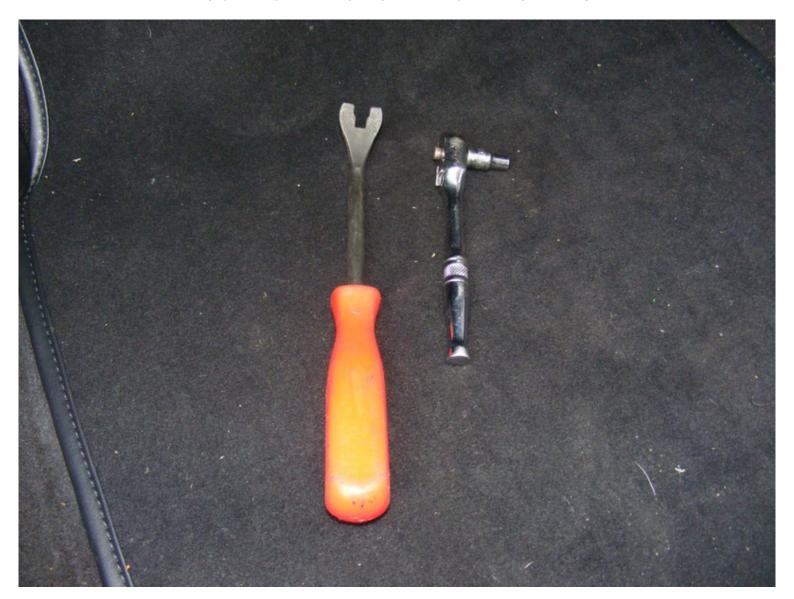
The only tools needed are:

A 6mm socket A pry tool (you could just pull it away the carpet though

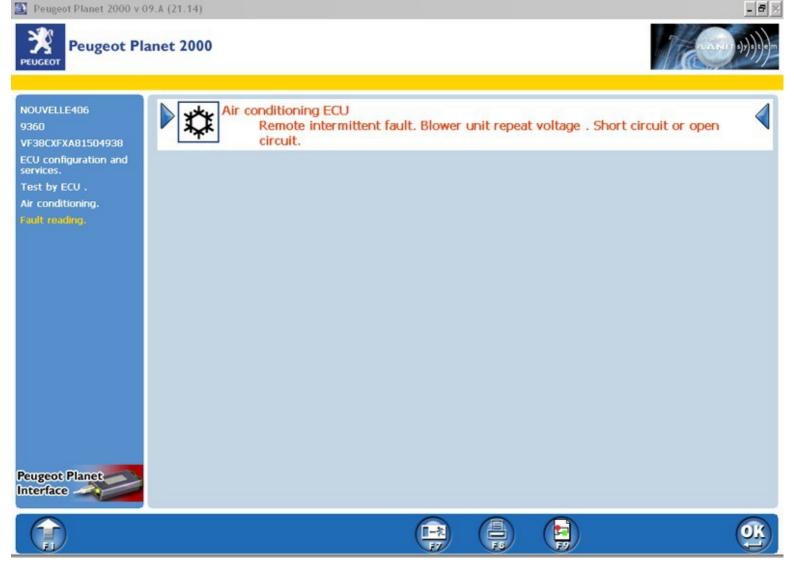
After checking the fuses & power to places, including the motor, which I removed & made up a small loom to connect directly to the battery to confirm it was working, which it was. Next thing I did was connect the coupe upto PP2000. In the BSI section the following fault was reported, even after clearing the fault it came right back:

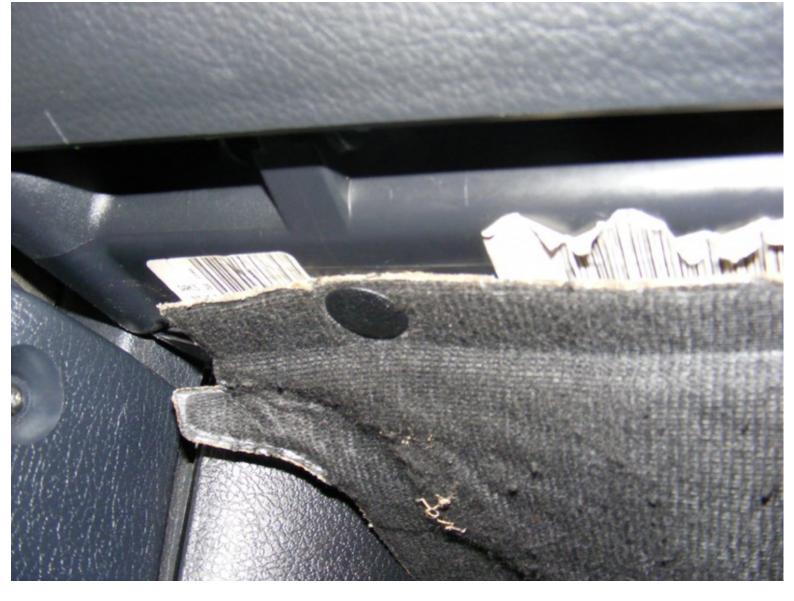
Look under the glovebox area & you'll see a small piece of carpet secured with 3 black push clips, similar to the yellow ones that hold the door cards on:

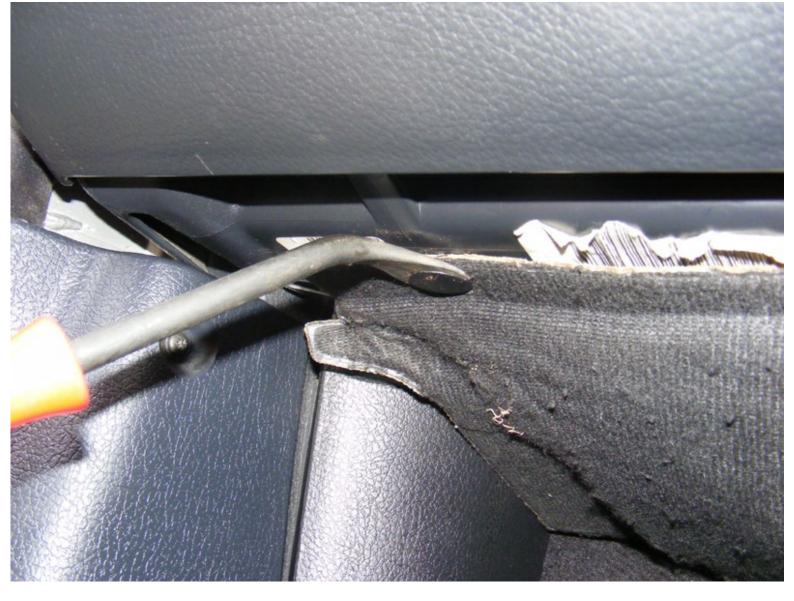
You could just pull these away, but I used the pry tool just for reference:

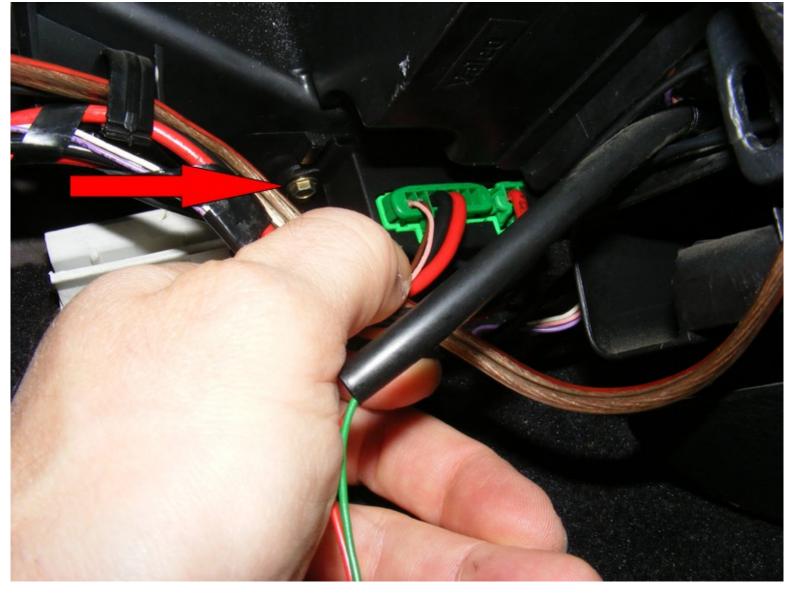
With that out of the way, here's your prize. Easily spotted with it's 2x green connectors. Also marked is the 6mm screw you need to remove. There's only the only, so if your new resistor has a hole on the other side like mine did, luckily Peugeot didn't fit that awkwardly placed screw:

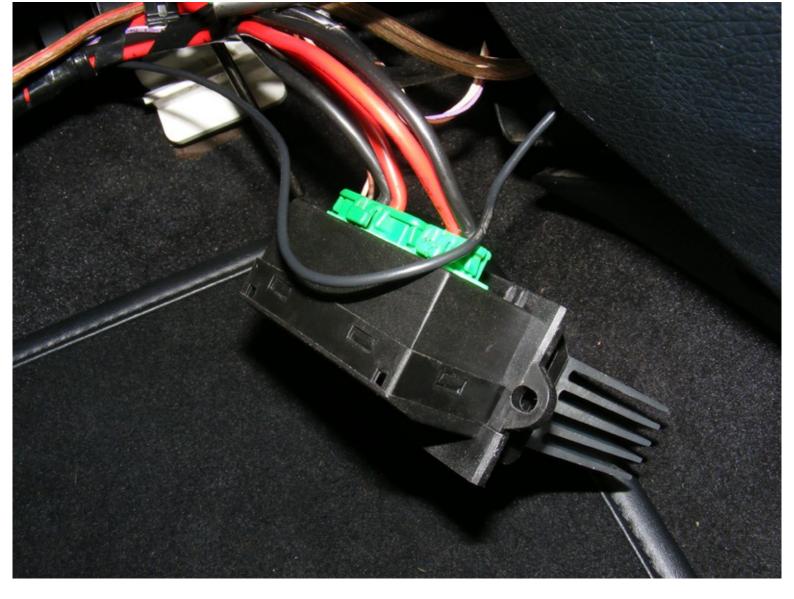
With it removed, just give it a bit of a wiggle whilst pulling it downwards & it'll come out easily:

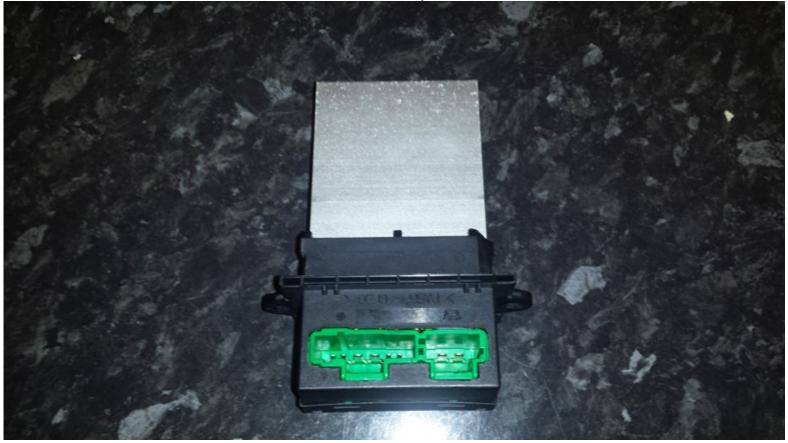
Just press the little green tab in on each of the connectors & they'll come off. Fitting is the reverse of removal.. No really, it is $^{\odot}$.
