Finally got round to fitting the new speed sensor today due to the dying speedo needle fault. Not too bad a job although access into the sensor is very tight and can only be done from underneath. That's on the V6 anyhow, as the inlet manifold and multiple hoses down there just get in the way. I couldn't even see it from above....

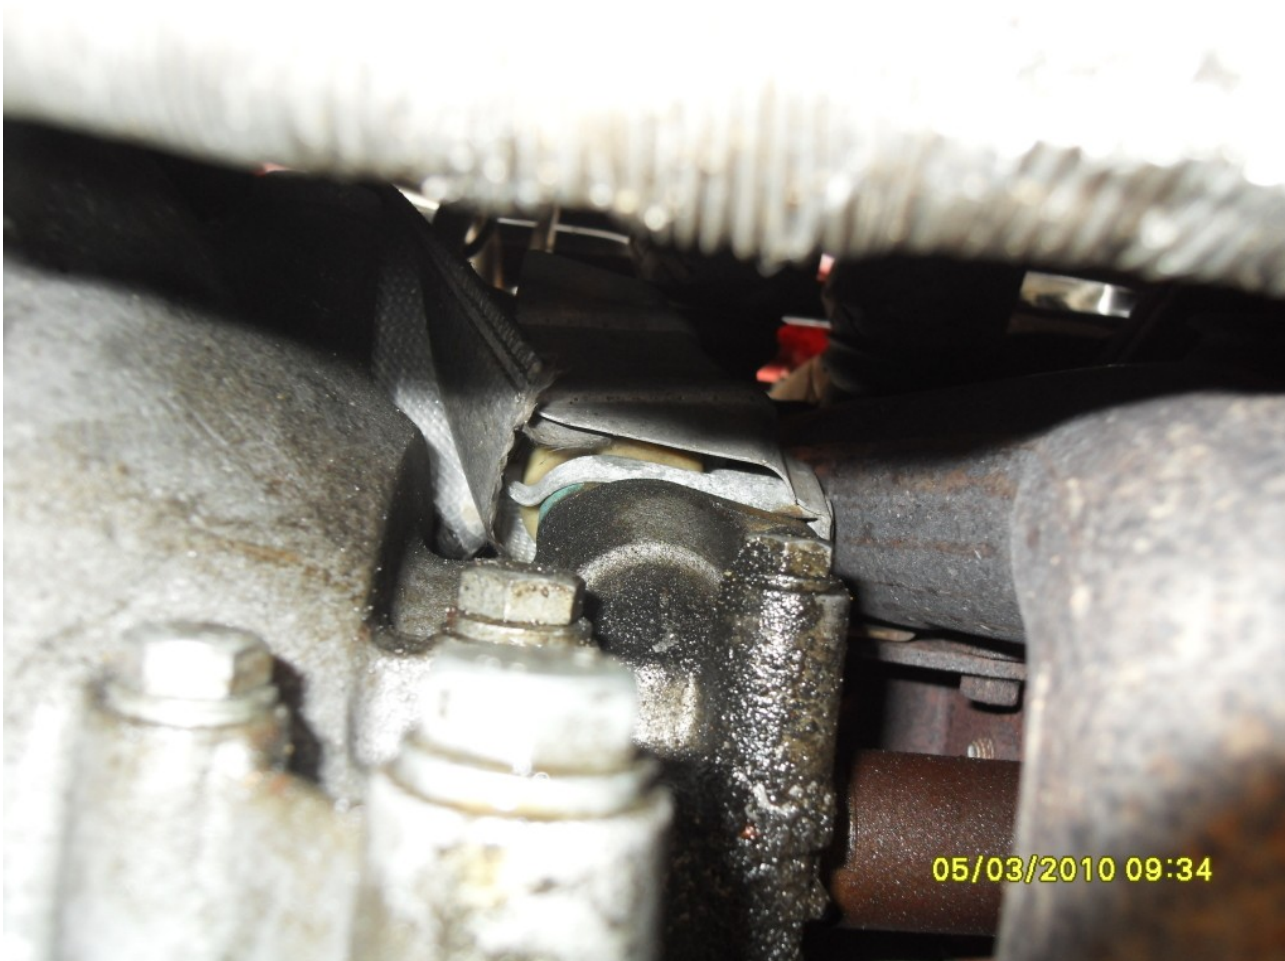
### **Looking up at the sensor**

It's the light colored object under the ally heatshield. (that's not a gearbox oil leak btw lol...this area is right next to the leaky joint I had on the high pressure power steering over Christmas. It's been cleaned now...)

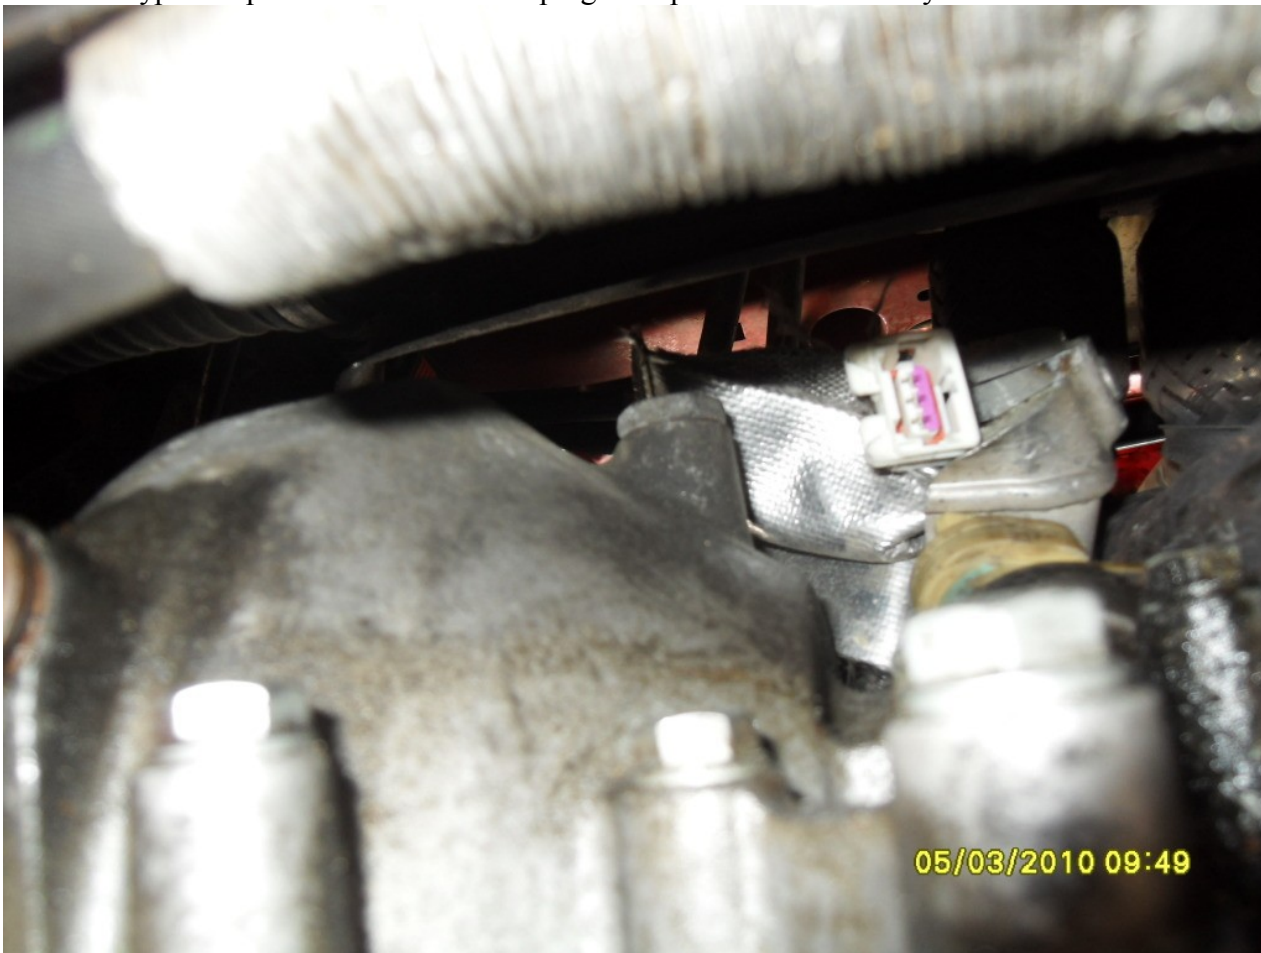
### Plug disconnected

Removal of the heatshield is fiddly but it comes off eventually to allow disconnection of the 3 pin plug. There's an 'asbestos' type heatproof cloth around the plug. Just pull it out of the way.

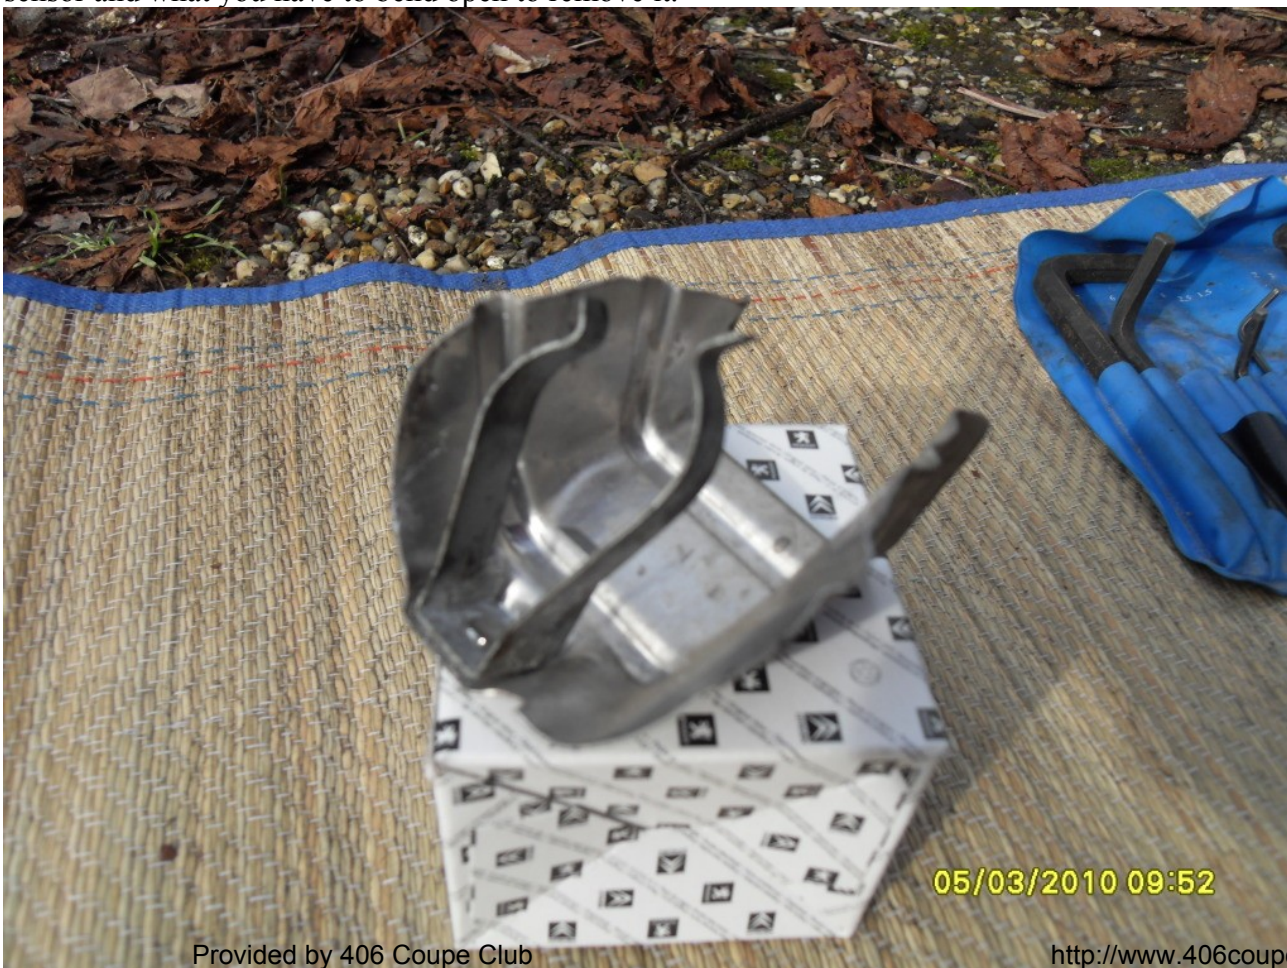
### Heatshield

This is what the heatshield looks like when it's been persuaded to come off. Those 2 spring clips are what hold it on to the sensor and what you have to bend open to remove it.

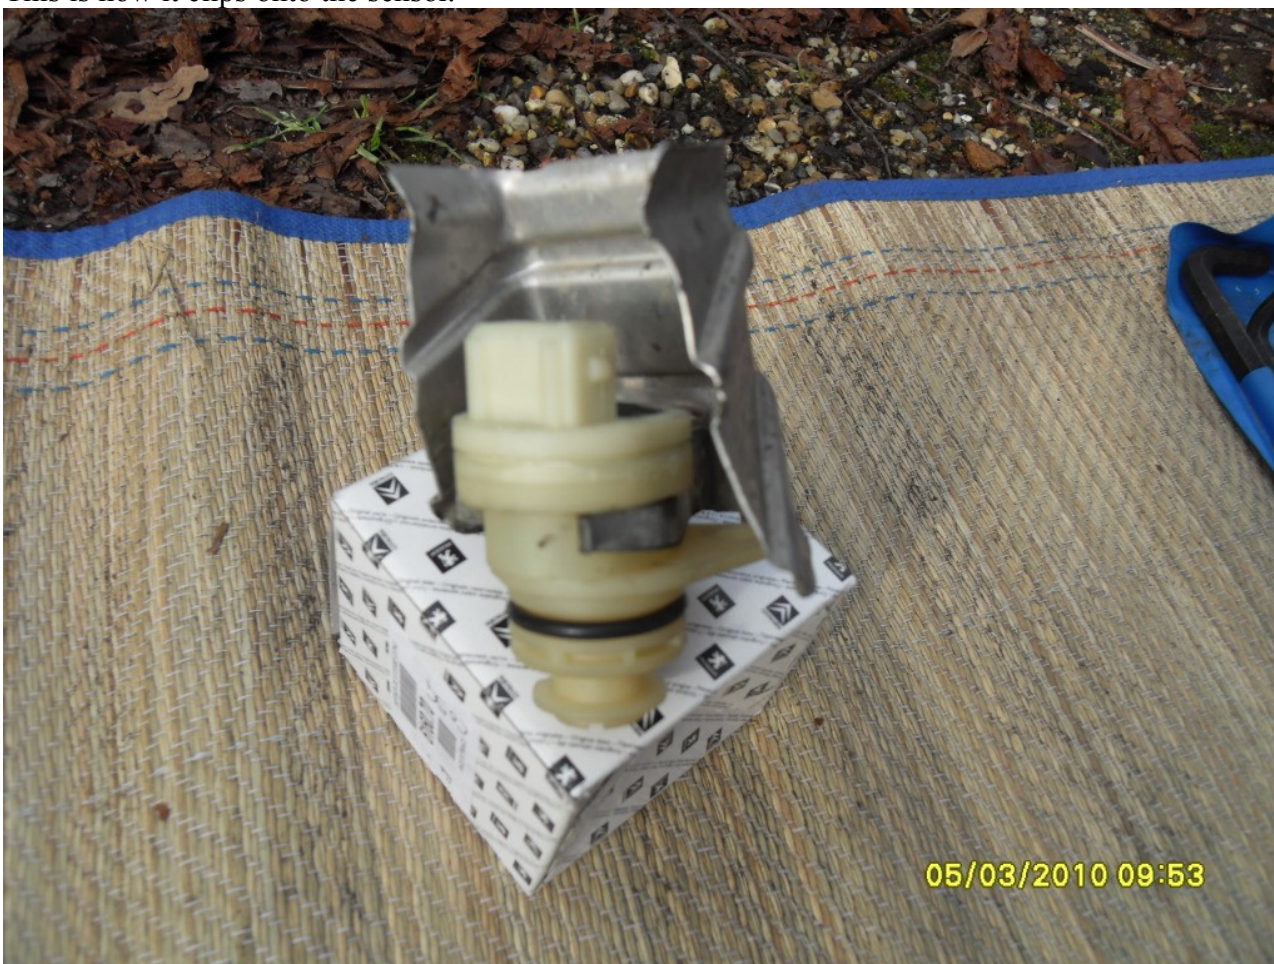
**Heatshield attached to sensor**  
This is how it clips onto the sensor.

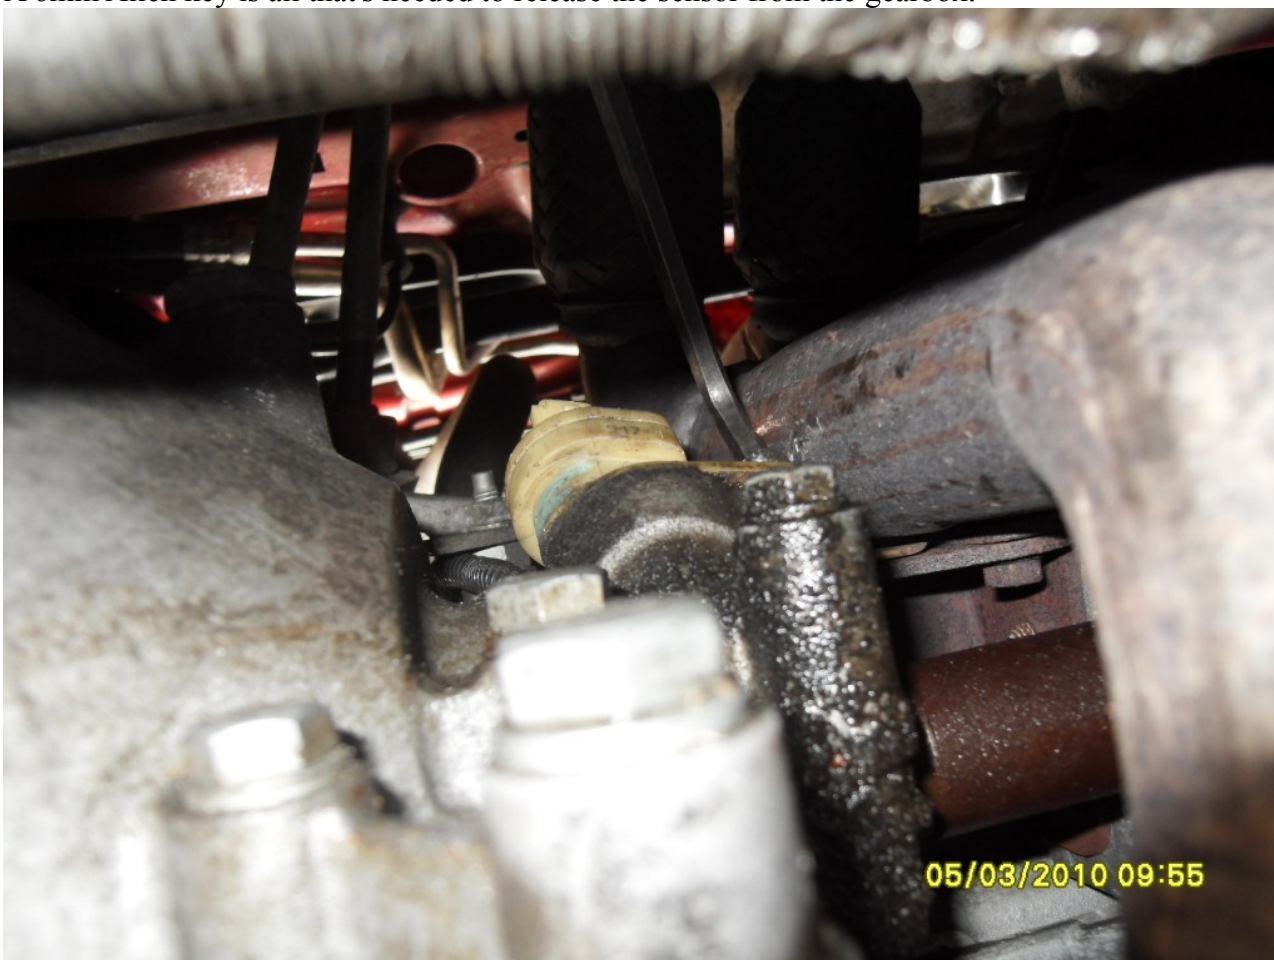
**Removing the Allen bolt**  
A 6mm Allen key is all that's needed to release the sensor from the gearbox.

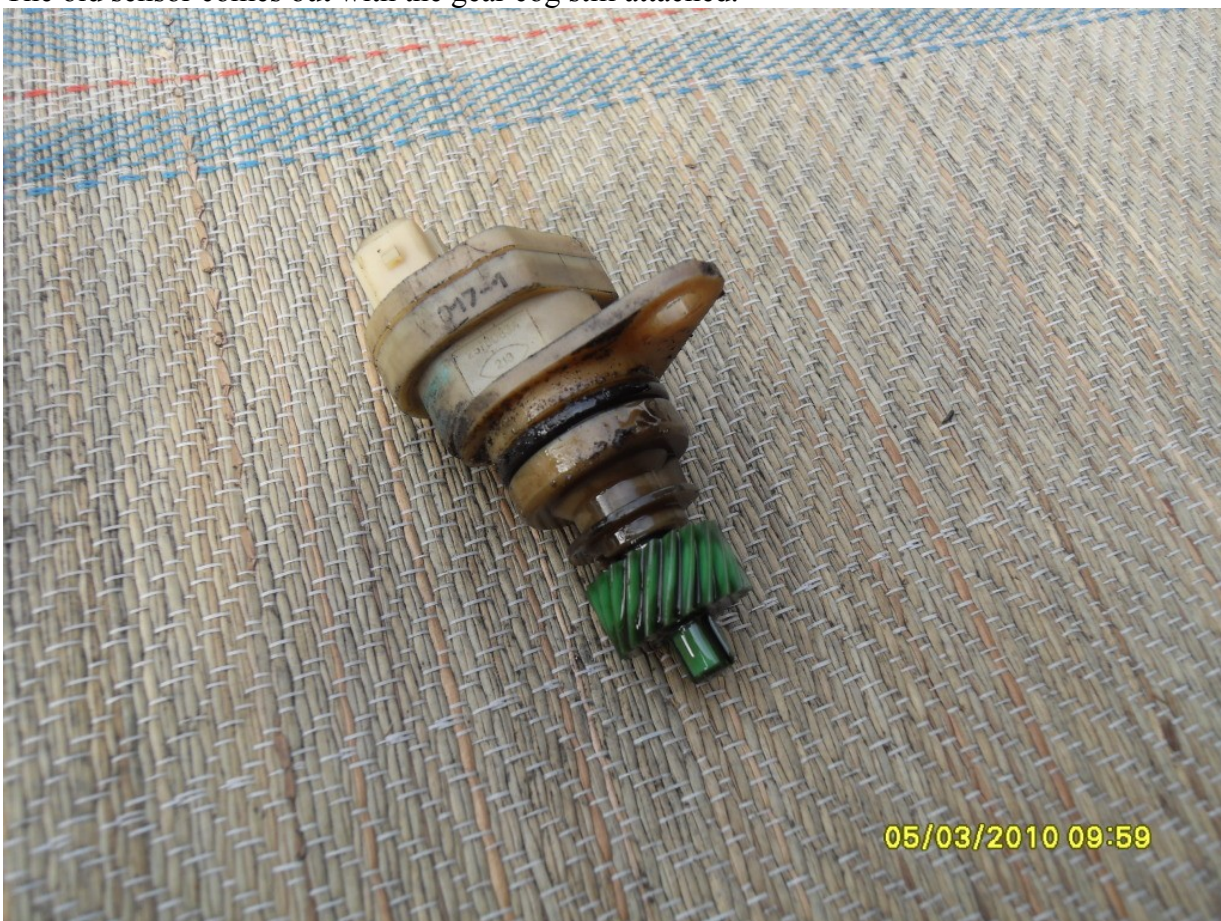
## Old sensor and gear

The old sensor comes out with the gear cog still attached.

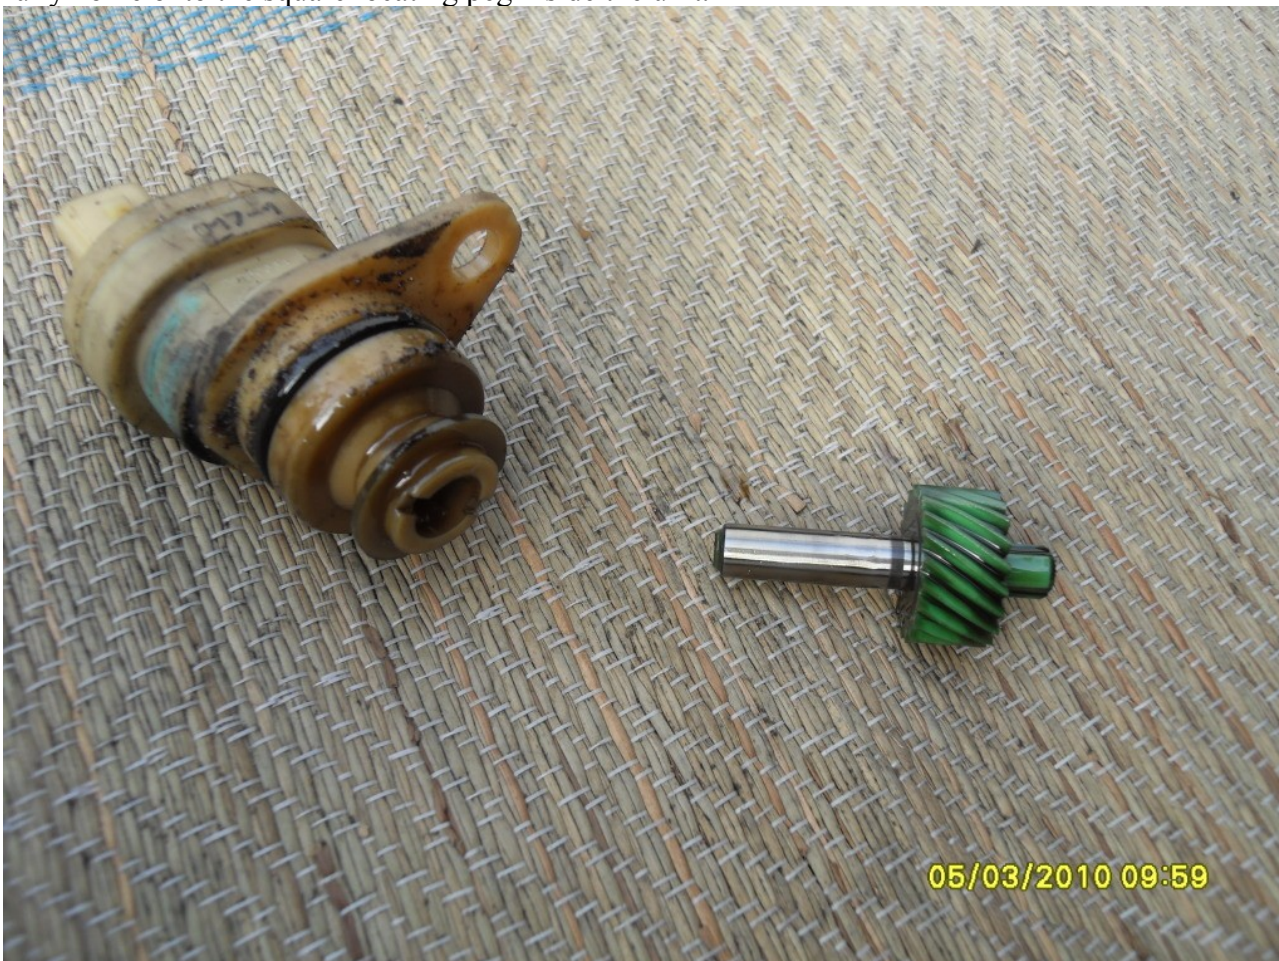
## Gear removed

The gear just pulls straight out from the bottom of the sensor and goes back onto the new one making sure that it is pushed fully home onto the square locating peg inside the unit.

It's just a case of putting it all back together in the reverse order, as they say.
