The outer ring on mine has never lit up, so due to a couple of recent threads I thought I'd spend 20 mins removing it.

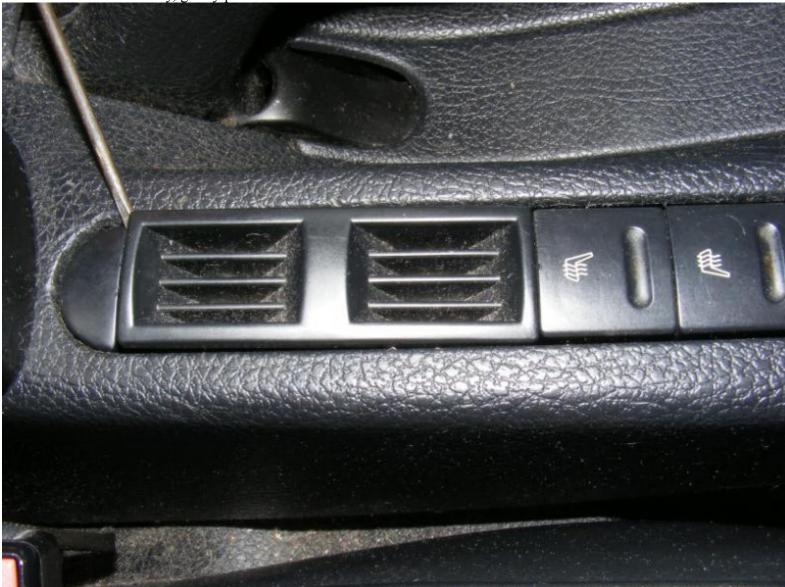
Firstly, gently prize the coin holder from the centre switches with the screwdriver:

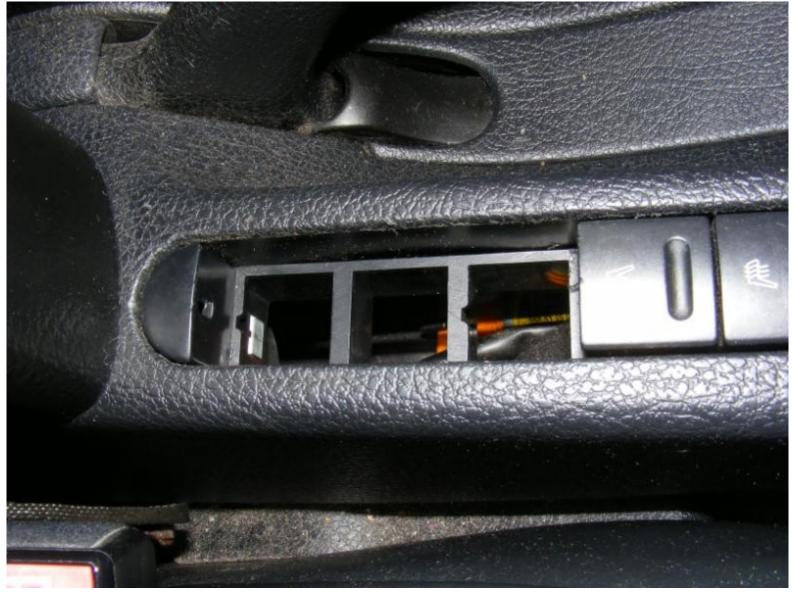
Once removed you're left with this:

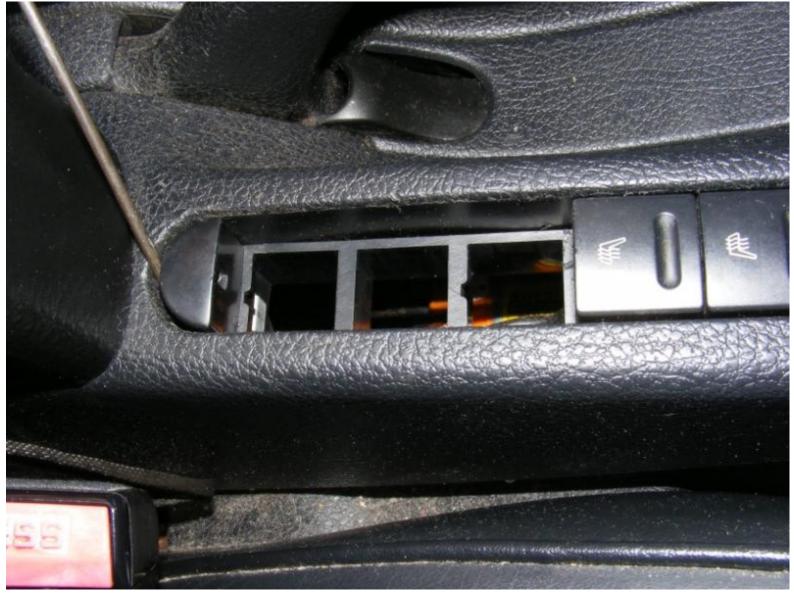
Now do the same for the entire swtich block. You need to be a bit more forceful as there's a small metal clamp on the screwdriver side to add tension. Don't do this from the other side as it has a long plastic locating tab, you don't want to break that:

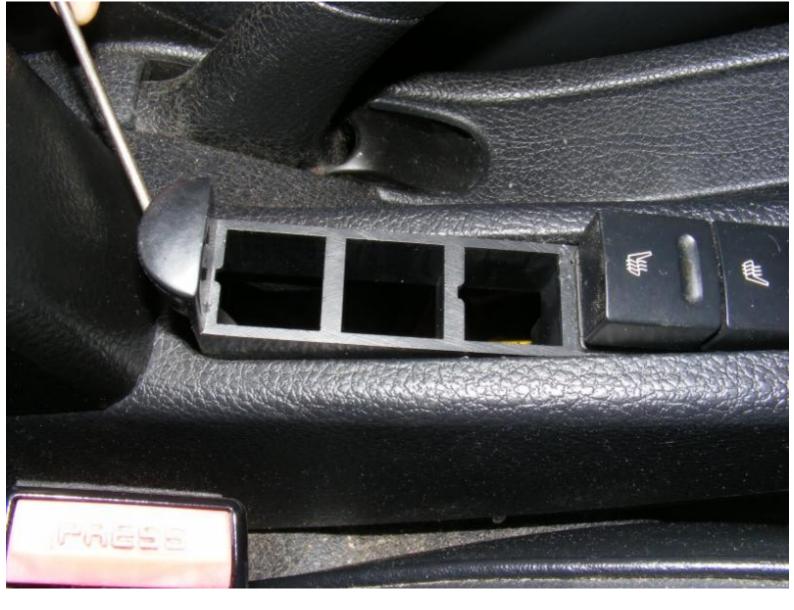
You'll be left with this once it's released. Don't lose that metal tab on the side:

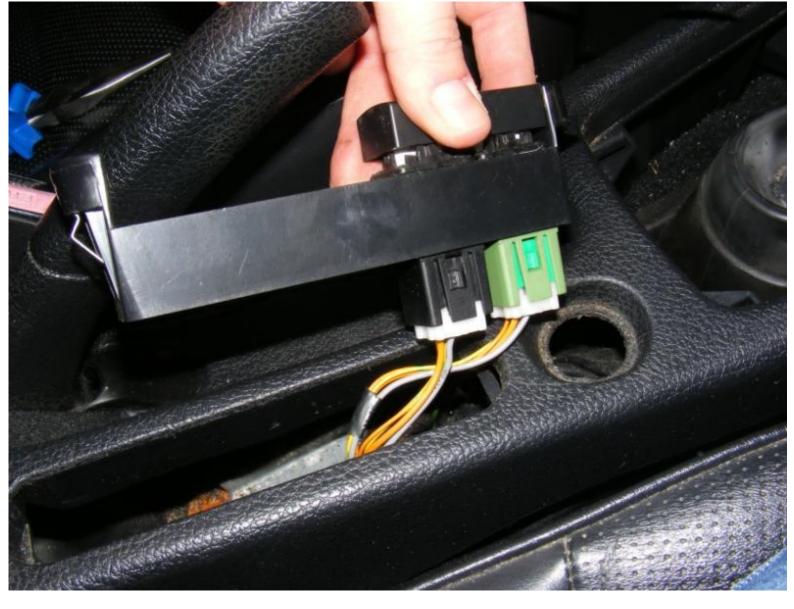
Lift the assembly out (see the metal clamp on the left) & unplug the 2 connectors from underneath. You'll need to gently bent the fixing tab away:

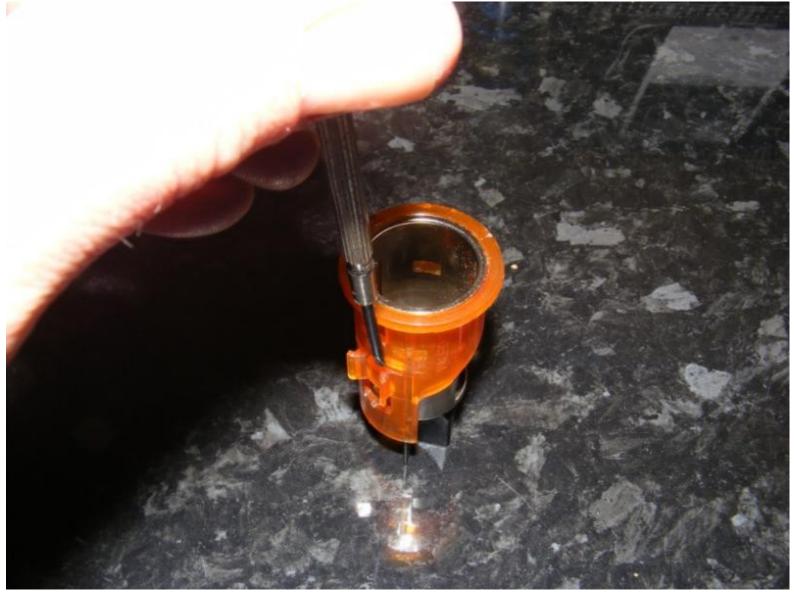
Just 2 shots to give you a better idea as to why it won't simply slide out. These 2 wings (which will be seen later in the guide) are what stop it coming out. What you need to do is push the screwdriver down the tiny gap between the console & orange part of the cig lighter & simply ease ease it upwards, it comes right out then:

Fitting will no doubt be a lot easier than removal, now you know what was stopping it from coming out in the first place.

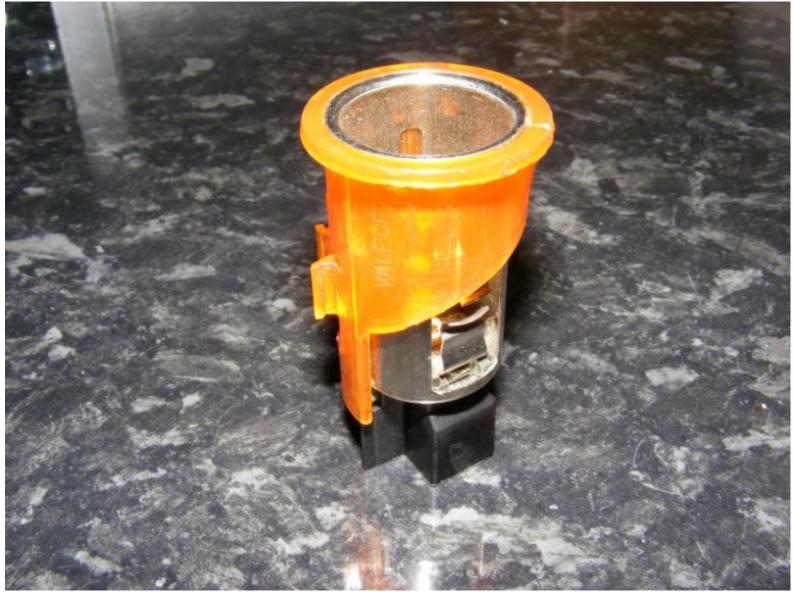
Side shot of the wings that give you grief:

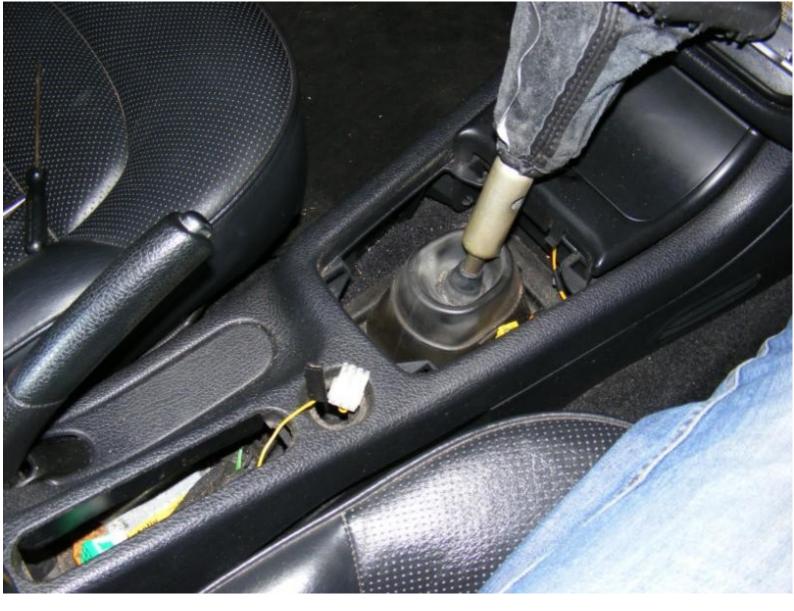
The 2 connectors that power it & the bulb:

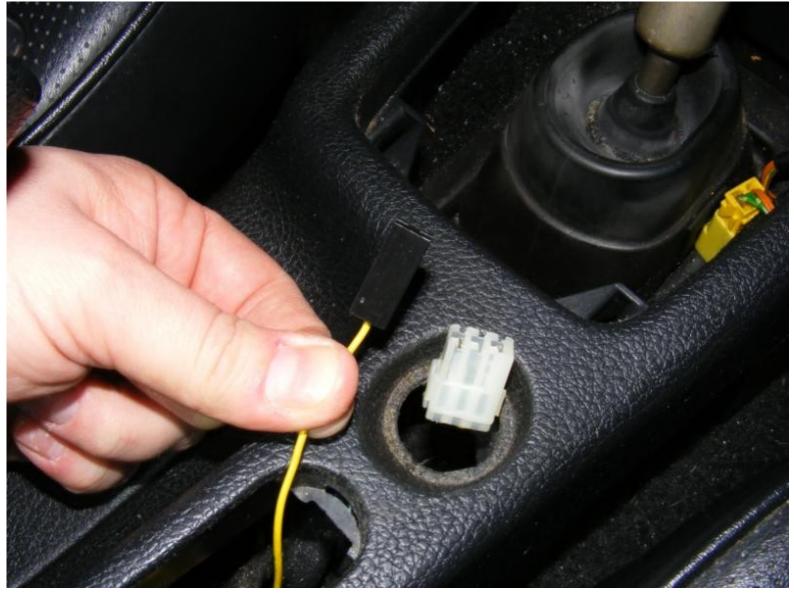
This is the one that plugs onto the actual bulb holder:

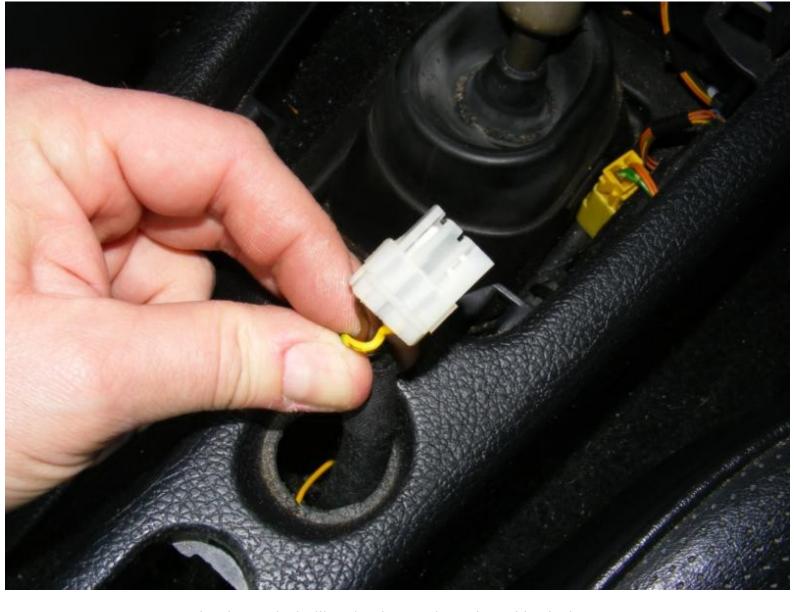
Here's the main plug that gives power to the socket:

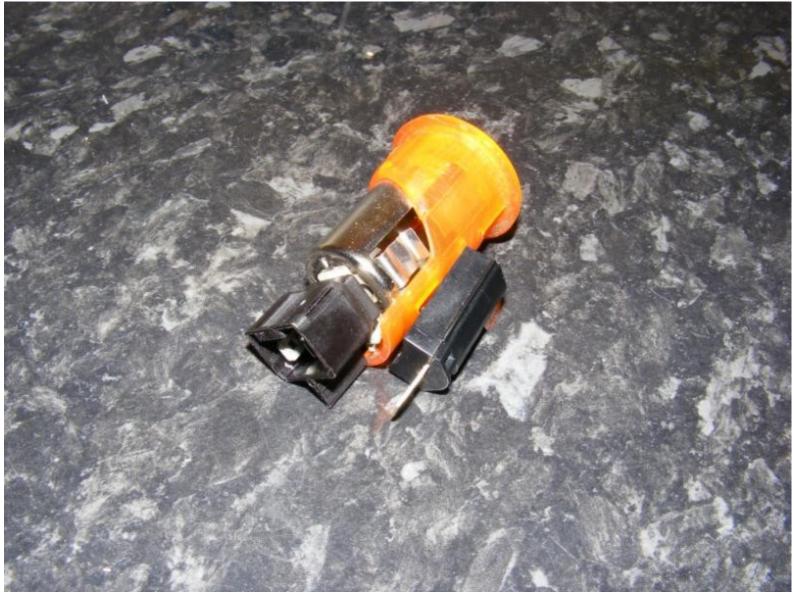
What the part looks like when it's together & in position in the car:

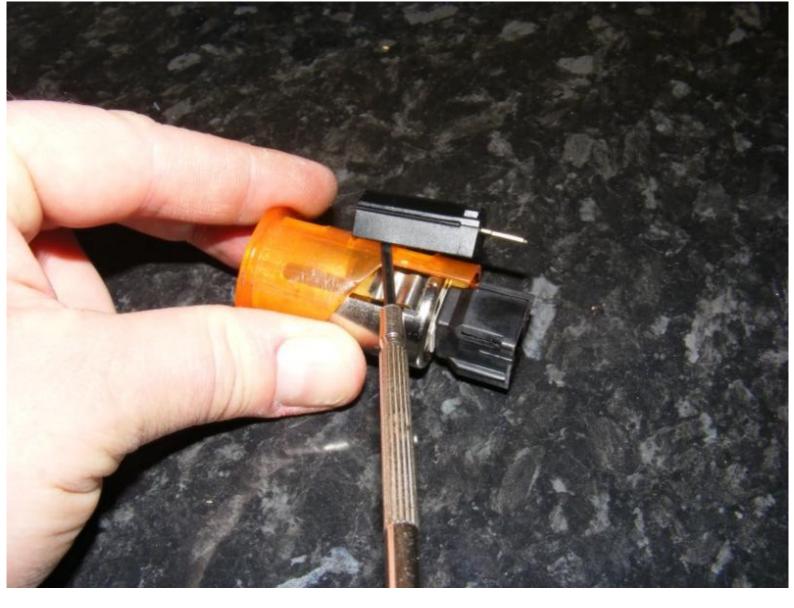
The small black part is the bulb holder. Mine pinged off inside the console but I managed to retrieve it. Gently prize it off with a small flathead screwdriver:

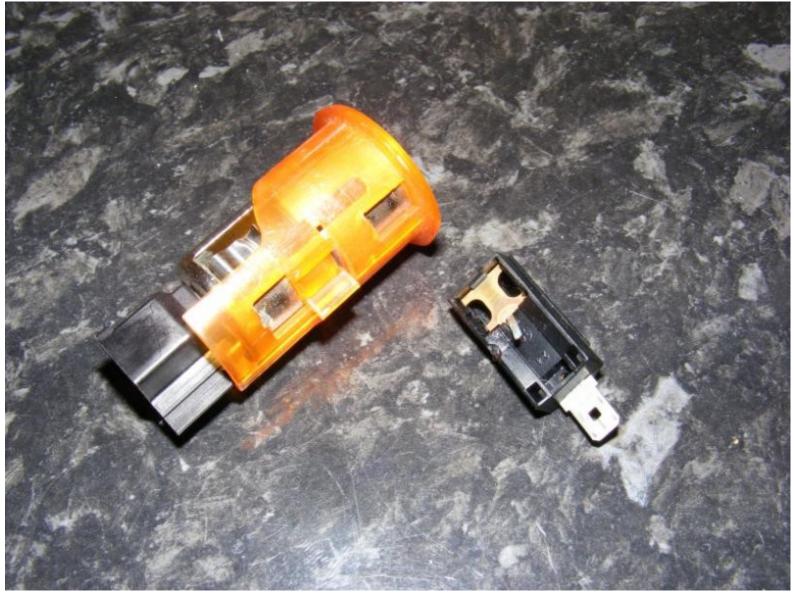
Now off the unit:

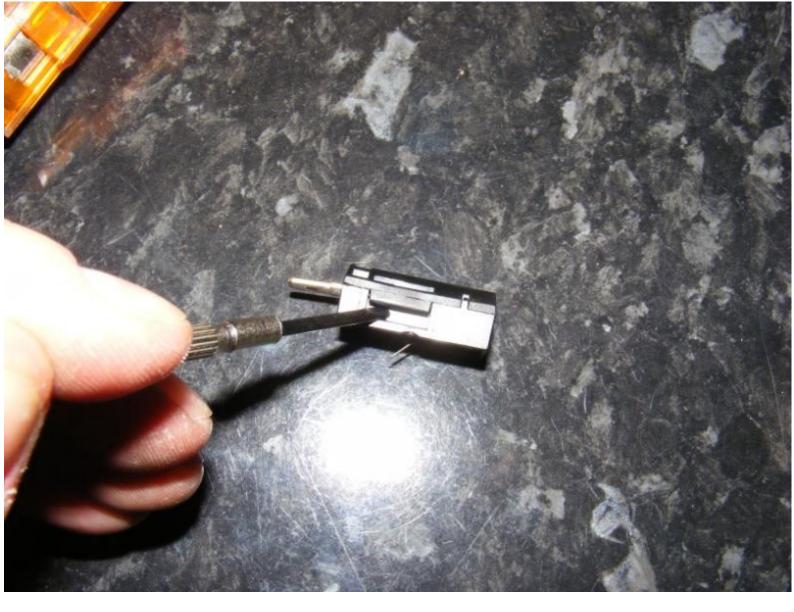
Using your tiny flathead, gently open the case up:

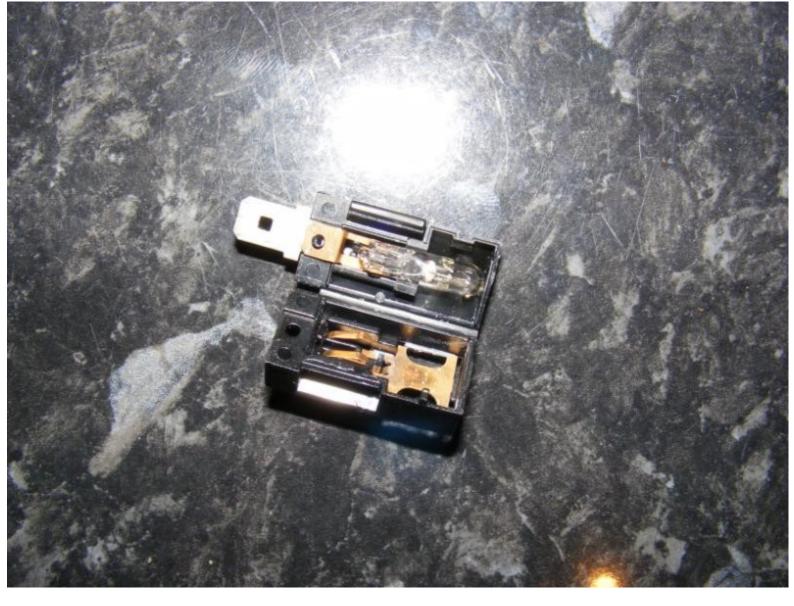
Et voila, one blown bulb:

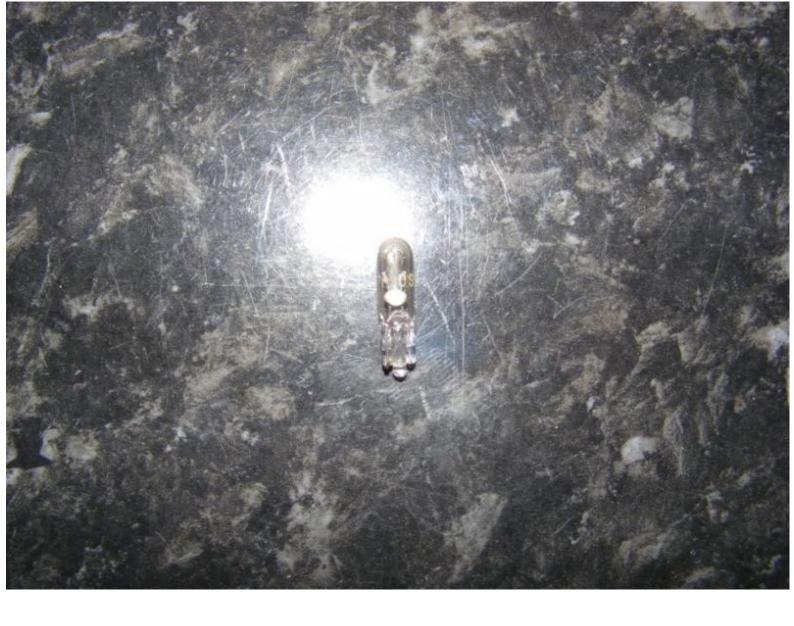
Bulb in question:
